Restoration of The Zaharakos Welte

by Durward R. Center

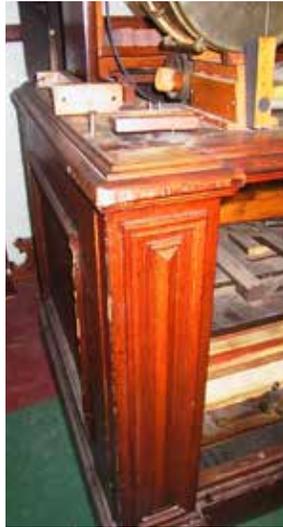
Figure 4

white oak. As found, the finish was a garish orange color and had beaded up to a very rough surface. The placement of the organ in front of the kitchen door and next to tables and chairs had allowed years of bumps and scrapes on the case from the floor up to about four feet. There were many splits and missing pieces of molding, not a crisp edge to be found. (Figure 4)

There was evidence that the case had been refinished at some point in the past. Brown stain was found on many inside corners. Residue from paint stripper was found in joints and cracks. One can theorize that this was done in the 1950's in an attempt to lighten the old dark finish to a more "modern" look.

As much as possible of the original wood of the case was kept. Missing molding pieces were remade, new oak was spliced into missing areas. The pockmarked surface in front of the roll frame was veneered. Once repairs were made, the finish was completely stripped, everything sanded and all stained with a golden brown stain to match the original appearance. A French polish finish was then applied, the traditional shellac finish for these instruments and other fine furniture. (Figure 5)

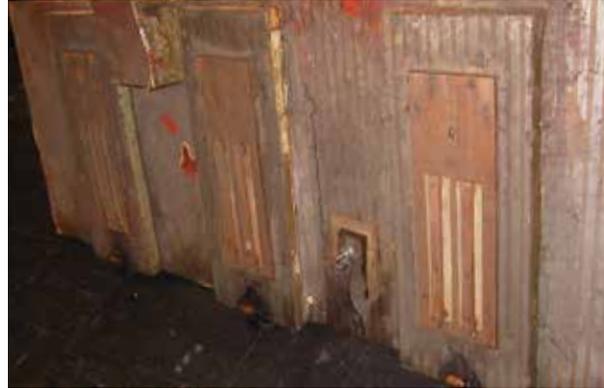
Figure 6

Orchestrions are pneumatically operated pipe organs. Both suction and pressure are required for their operation. Vacuum is used to read the music roll. The vacuum pump, or bellows, is located at the lower most level of the case. It consists of three feeder bellows and a reservoir to store vacuum. It is basically wood frames and leather. When found, much of the original leather was still in place and very rotten. It had been recovered in numerous places and several times with various materials in an attempt to keep it airtight. Every adhesive device known to man was found including silicone sealant,

staples, caulking and tons of white glue. And, of course, duct tape. (Figure 6)

Everything had to be removed down to bare wood. Cracks were then shimmed, new edges spliced onto damaged components, every screw hole drilled, plugged and redrilled for proper size screws.

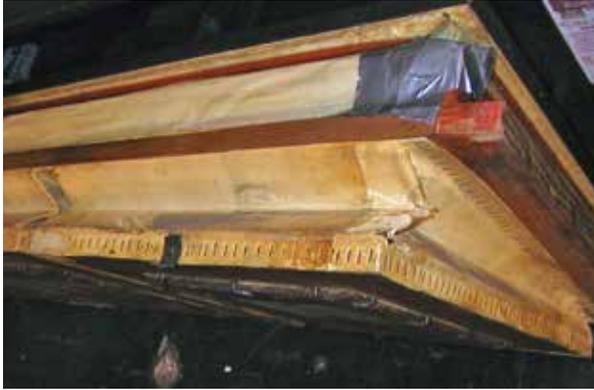
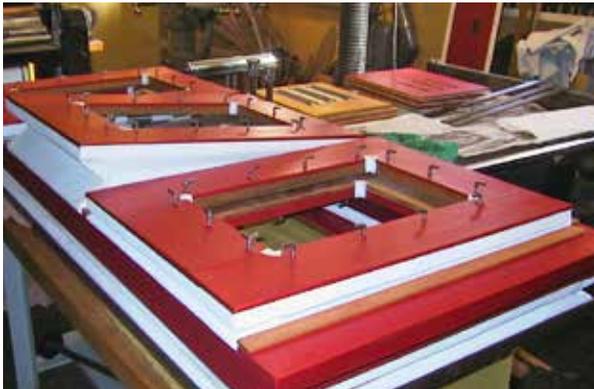
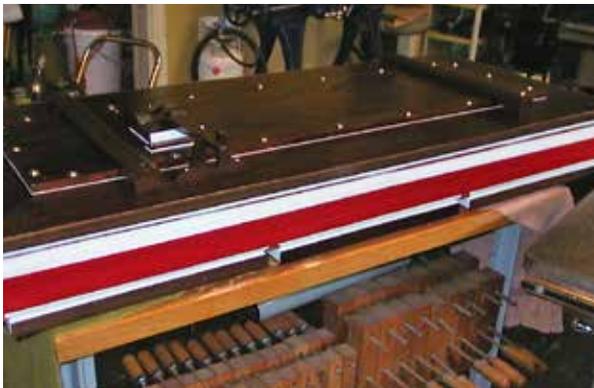
The pressure pump is located just above the vacuum pump. It also has three feeder bellows and a large reservoir on top. Pressure is used to blow the organ pipes. This unit was in a similar condition as the vacuum pump and required the same treatment. In addition, the three plates on which the flap valves are mounted had been replaced with plywood. New pine plates were made. (Figures 9, 10, 11)

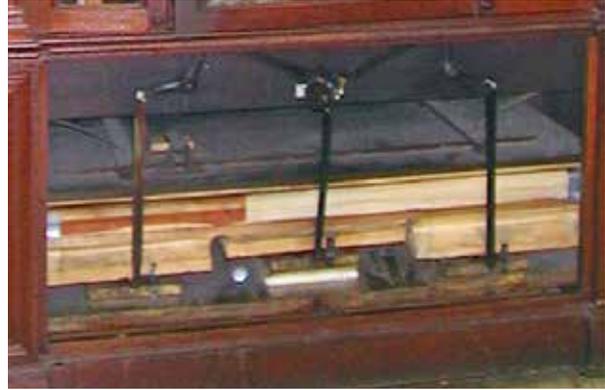
Figure 12

would speed the crank shaft up by placing larger pulleys on the motor and eventually by replacing the original motor altogether with a modern electric gear drive system. This increased the pressures lost through leakage. However, by 2006 the crankshaft was turning so fast as to cause the organ to self-destruct. The original steel connecting rods had one quarter inch of wear in each end and their pins were worn half way through. Replacement rods

were also found in the same condition. The main bearing supports had been modified with modern ball bearings and a crude replacement crankshaft. With the crank turning at about 80 rpm, the shock on the iron castings of the bell cranks and eccentric had caused all of them to crack or break. Not to mention the clattering of all this going on inside the case. (Figure 12)

It was decided to start fresh and reproduce

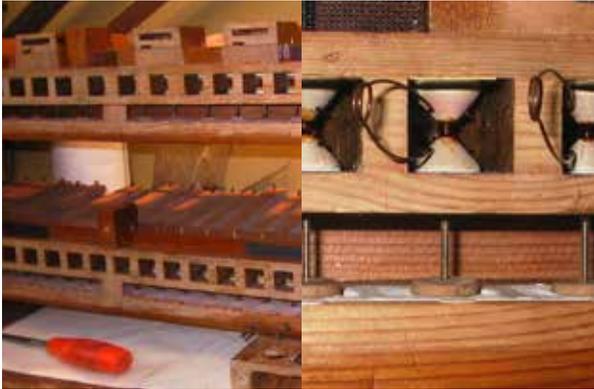
Figure 16

There is little room for leakage or lost motion in the components of this unit for proper playing of the organ. As found in 2006, numerous modifications and repairs had been made. *(Figure 16)*. Splits within the channeling had rendered the registration functions inoperable.

All components were dismantled, stripped of leather, glue and finish in preparation for repairs and re-leathering. Areas with splits in the channeling were replaced and all channels and air ducts were sealed with shellac so as to be completely air tight.

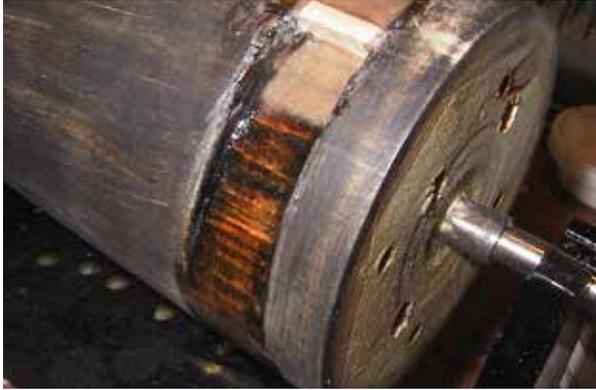
Figure 21

blend in the repair. Both shaft ends of the take-up spool were badly worn. Each end was cut off, bored and a new shaft extension pressed in, then turned to the proper dimensions. (Figure 21)

The scored area of the take-up spool was filled with epoxy and then turned on the lathe to

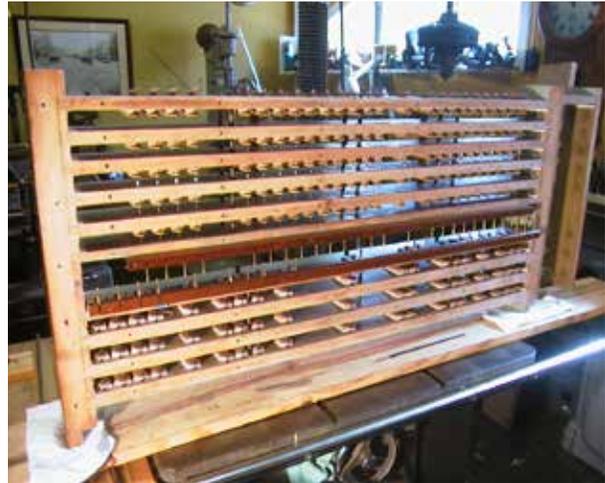
Figure 29

The leather valve facings on the pallet valves had been replaced, as well as the pallet pull wires. It was felt for optimum operation, they should be stripped and redone to factory specs. All channels were resealed with shellac. A double layer of sheep skin was used for the valve facing and kangaroo leather used for the tail hinges. (Figure 28) New pull wires were installed to move the valves. New return springs were made. (Figure 29) The top surface of the wind chest was then covered with a leather

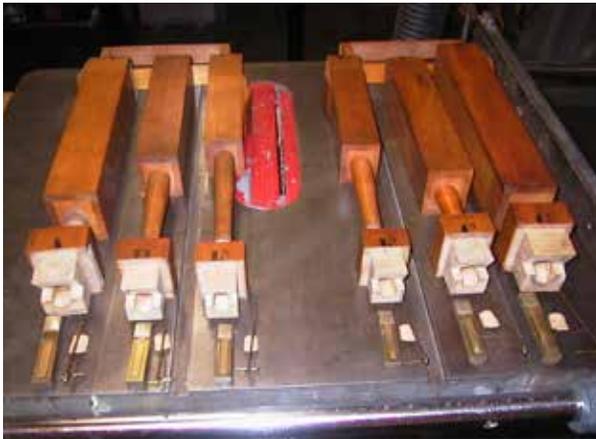
Figure 35

had their tuning stoppers releathered, or their tuning slides removed and cleaned. The silver tin pipes in the very front of the display had all dents removed, tuning scrolls remade and were then polished and lacquered. The brass pipes also required dent removal, polishing and lacquering. These pipes had lost their regulating plugs. These are wood sleeves fitted inside the bottom of each resonator and bored out to control the volume of each pipe. (*Figure 34*) Each brass pipe fits into a reed boot which contains a tunable free brass reed. These were also in excellent condition and only required cleaning. (*Figure 35*)
