Restoration of The Zaharakos Welte

by Durward R. Center

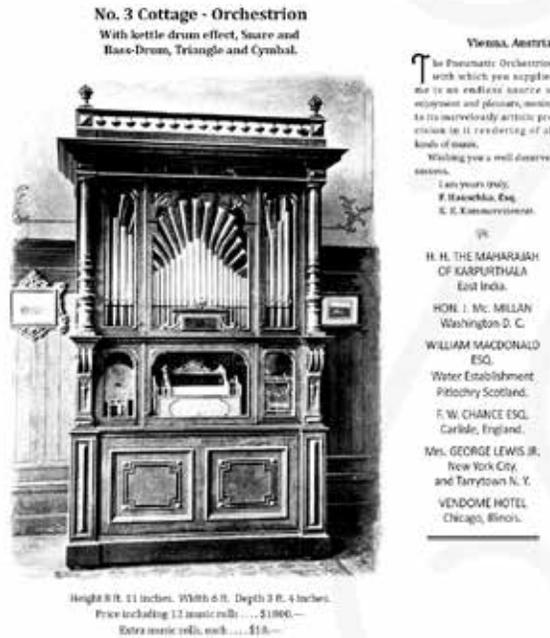
Figure 1

It was only natural that the brothers Zaharako would choose to install one of these instruments in their beautiful well appointed ice cream parlor in 1908. They purchased a Style #3 Cottage Orchestrion. (Figure 1) The Style #3 is one of the smaller machines which Welte offered, but none the less, it was sized just right for the room.

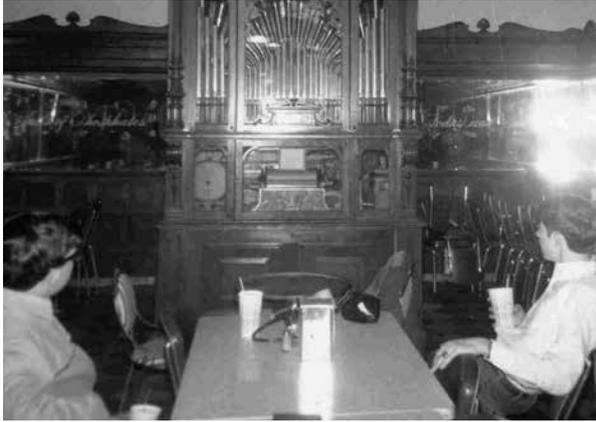
Figure 2

As an interesting note, your writer first saw this organ in 1967 when he was a mere boy in high school. (Figure 2) Living and breathing all things pipe organ, he and some friends came from Kentucky to see this unusual instrument. The impression this organ made was to last a lifetime.

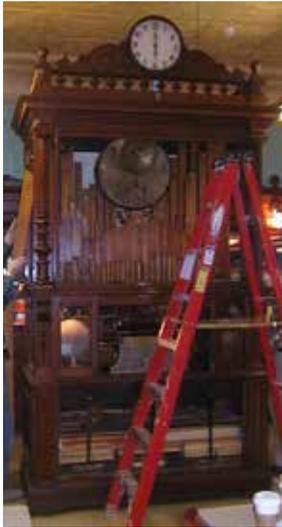
Figure 3

It was in this condition when in 2006 it was decided to completely restore the instrument back to its former glory. Your writer was honored to have been chosen to do this work. In March of that year, the organ was carefully dismantled, packed and shipped to Baltimore, Maryland. (Figure 3)

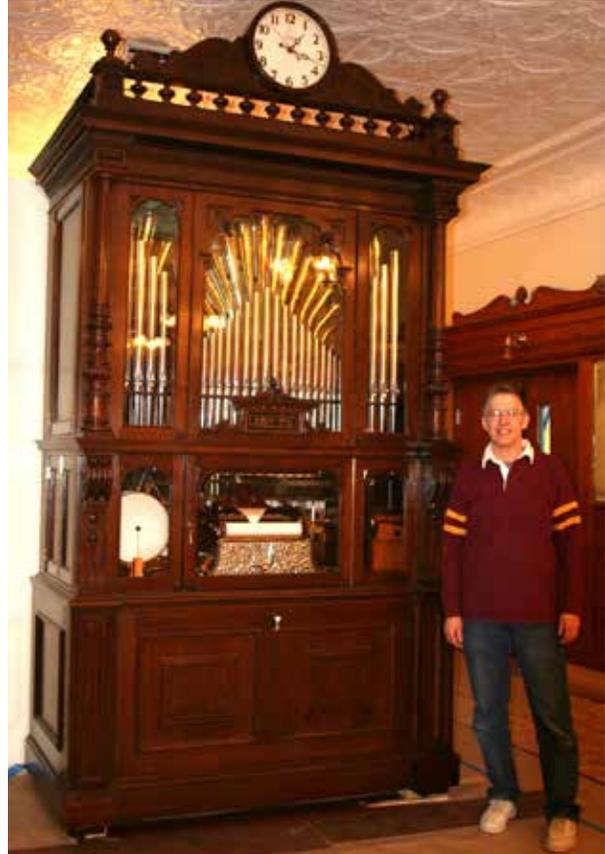
Figure 41

Durward R. Center stands next to the restored Welte at Zaharakos in 2008. *(Figure 41)*
